Final Report 2001 - 06  
August 30, 2001

**REMOTE SENSING DEVICE  
HIGH EMITTER IDENTIFICATION  
WITH CONFIRMATORY ROADSIDE  
INSPECTION**

*Bureau of Automotive Repair  
Engineering and Research Branch*

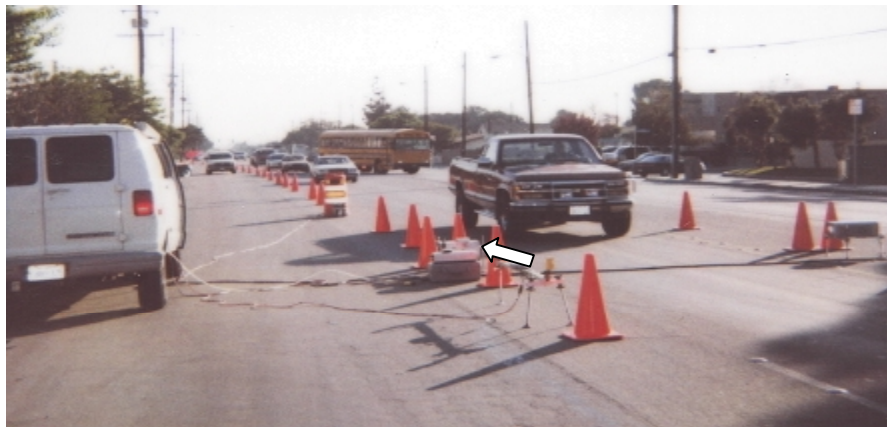
**FIGURE 1**  
**RSD Surface Street Setup**

*Note: Arrow indicates RSD.*

Beginning on May 23, 2000, BAR's air quality representatives (AQRs) used RSD to identify and a portable BAR-97 EIS to inspect targeted vehicles. During the study, BAR visited several Southern California enhanced area sites. The typical lane configuration included two Fuel Efficiency Automobile Test (FEAT) remote sensing devices, placed upstream of the roadside inspection equipment. Upon viewing emission readings exceeding pre-determined levels, the RSD operator radioed the California Highway Patrol (CHP) officer to pull over each high emitting vehicle for immediate roadside inspection. Figure 1 shows the RSD portion of a typical inspection lane.

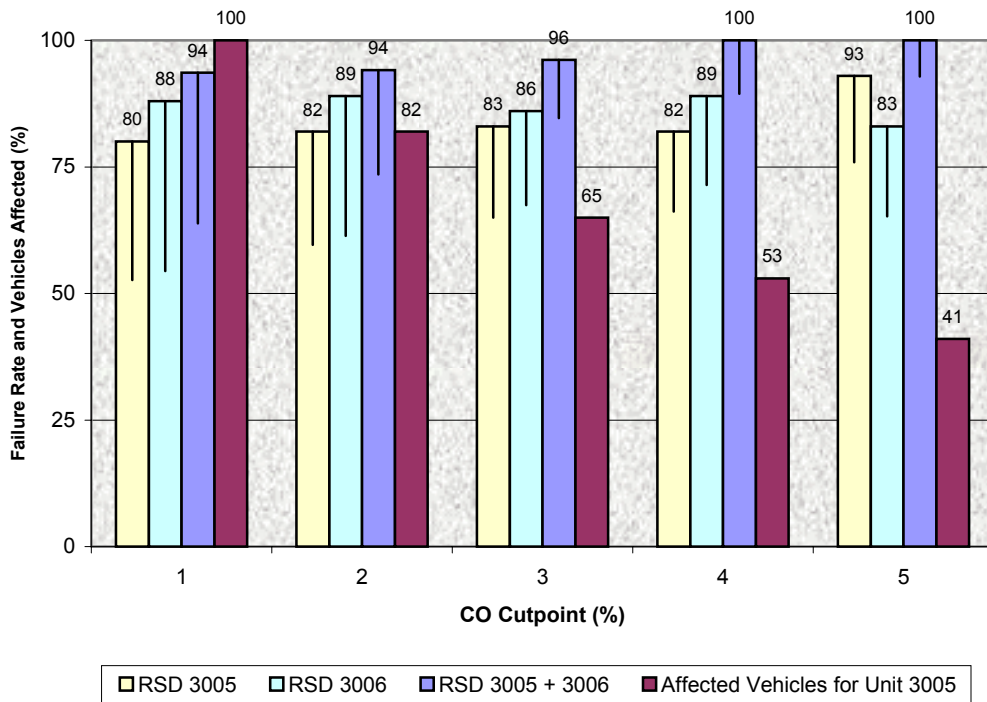
**FIGURE 4**  
**ASM Inspection Failure Rate for RSD Identified CO HEVs**

*Note: Lines within bars indicate the portion of the ASM inspection failure rate due to other than CO failure.*

Historically, RSD CO readings have been a reliable identifier of high emitting vehicles. Figure 4 shows an increasing success rate (ASM inspection failure rate) as the RSD CO cutpoint increases; however, the percentage of affected vehicles decreases with an increasing RSD cutpoint.

Given enough test equipment, approximately 8% of the on-road fleet could be targeted using a cutpoint of 1% CO to pull-over vehicles. At CO pull-over cutpoints of 2%, 3%, 4% and 5%, we could affect approximately 8%, 5%, 4%, 3% and 2%, respectively, of the passing fleet.

Figure 4 also shows that CO identification by two RSDs instead of one RSD assists in the successful identification of high emitting CO vehicles. In most cases, for each cutpoint shown, the failure rate with multiple RSD readings is larger compared to the failure rate when the vehicle is identified by a single unit. So, when two RSD units are operating a lower CO cutpoint could be used.

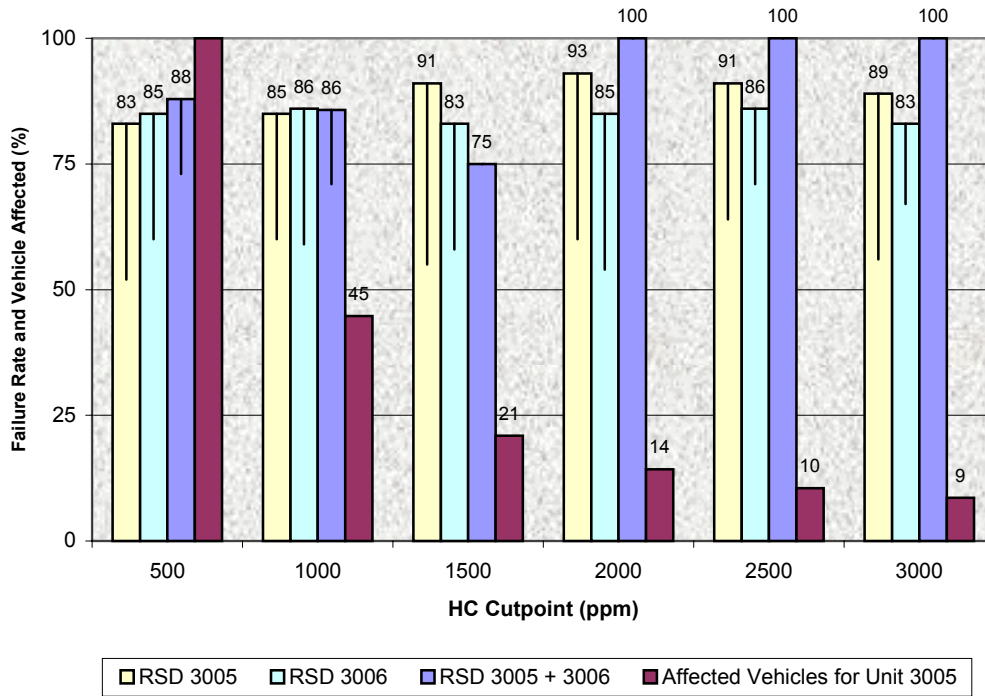
**FIGURE 5**  
**ASM Inspection Failure Rate for RSD Identified HC HEVs**

*Note: Lines within bars indicate the portion of the ASM inspection failure rate due to other than HC failure.*

Next, hydrocarbon HC RSD cutpoints were plotted against the ASM inspection failure rate in Figure 5. In general, RSD 3005 displays the same trend of increasing failure rate with increasing RSD cutpoint, however, the percentage of vehicles rapidly decreases.

Given enough test equipment, approximately 10% of the on-road fleet could be targeted using a cutpoint of 500 ppm HC to pull over vehicles. At 1000, ppm, 1500 ppm, 2000 ppm, 2500 ppm and 3000 ppm, we would affect 4%, 3%, 2%, 1% and 0.8%, respectively, of the passing fleet vehicles.

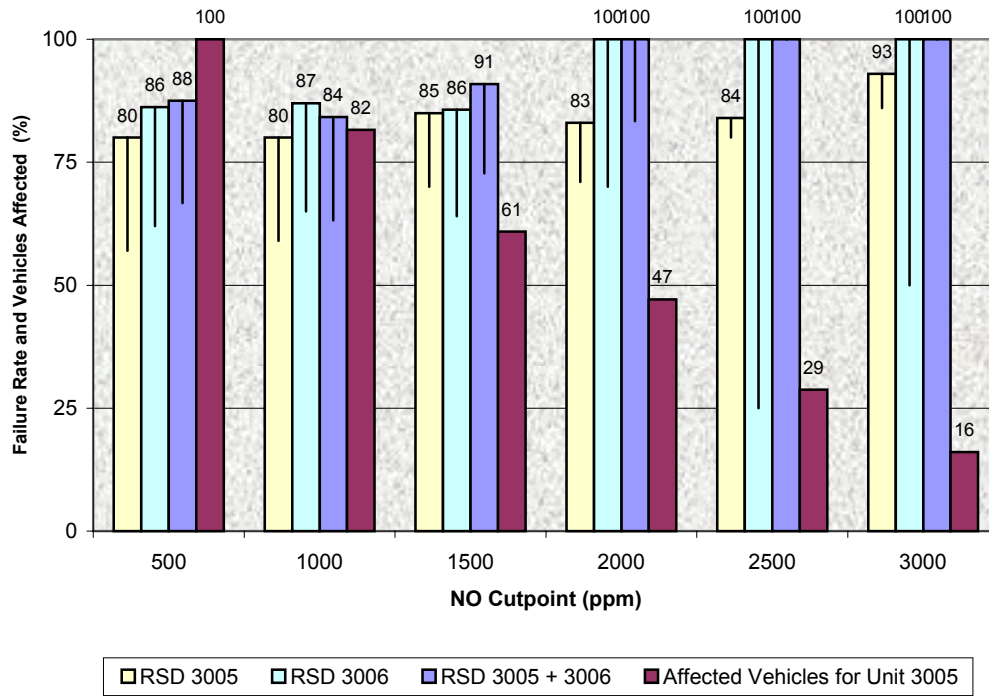
**FIGURE 6**  
**ASM Inspection Failure Rate for RSD Identified NO HEVs**

*Note: Lines within bars indicate the portion of the ASM inspection failure rate due to other than NO failure.*

Figure 6 shows NO RSD cutpoints and the ASM inspection failure rate. Again, the increasing failure rate with increasing RSD cutpoint trend exists, with the percentage of affected vehicles decreasing. In general, we can also see that NO identification by two RSDs instead of one RSD provides a higher rate of successful identification as measured by a confirmatory ASM inspection test.

Given enough test equipment, approximately 12% of the on-road fleet could be targeted using a cutpoint of 500 ppm NO to pull over vehicles. At 1000, ppm, 1500 ppm, 2000 ppm, 2500 ppm and 3000 ppm, NO pull-over cutpoints, we would affect 6%, 3%, 2%, 1.5% and 1%, respectively, of the passing fleet vehicles.

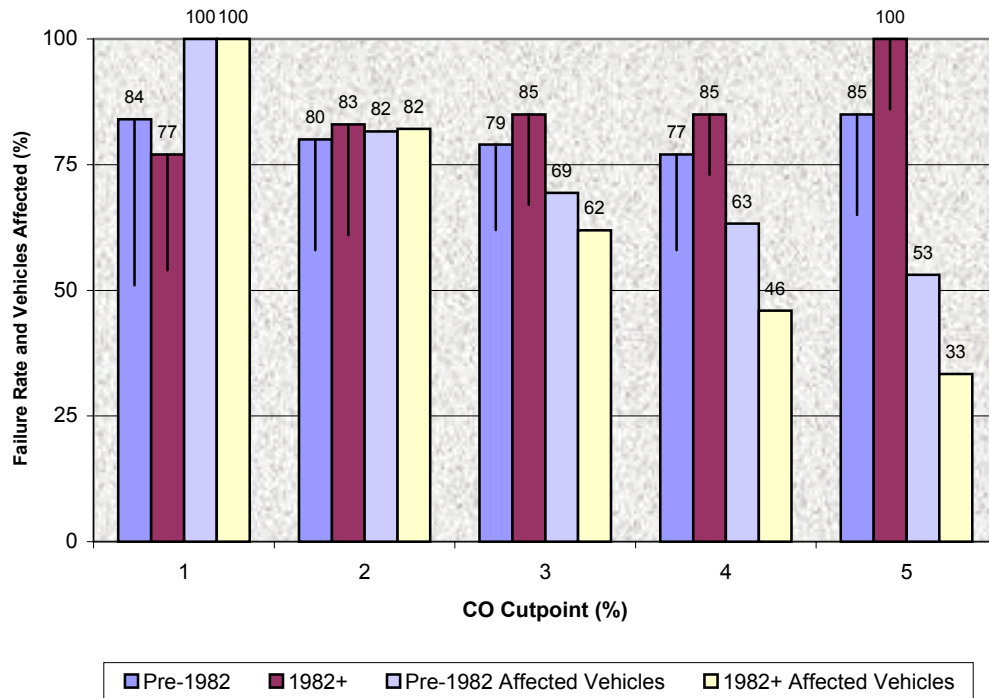
**FIGURE 7**  
**ASM Inspection Failure Rate for RSD Identified CO HEVs**  
**By Model Year Group for Unit 3005**

Note: Lines within bars indicate the portion of the ASM inspection failure rate due to other than CO failure.

Finally, using unit 3005, the vehicles were partitioned into two model year groups with pre-1982 in one group, and 1982 and newer in a second group. For the pre-1982 group, the ASM inspection failure rate for RSD identified CO HEVs decreased with increasing cutpoint as shown in Figure 7 (page 11). However, the ASM inspection failure rate increased with increasing cutpoint for the later model vehicles identified as CO HEVs. This trend would suggest a lower RSD CO cutpoint for pre-1982 vehicles than for 1982 and newer vehicles. This pattern was not observed in the RSD HC or NO identified HEVs as shown in Figures 8 and 9 on page 12.

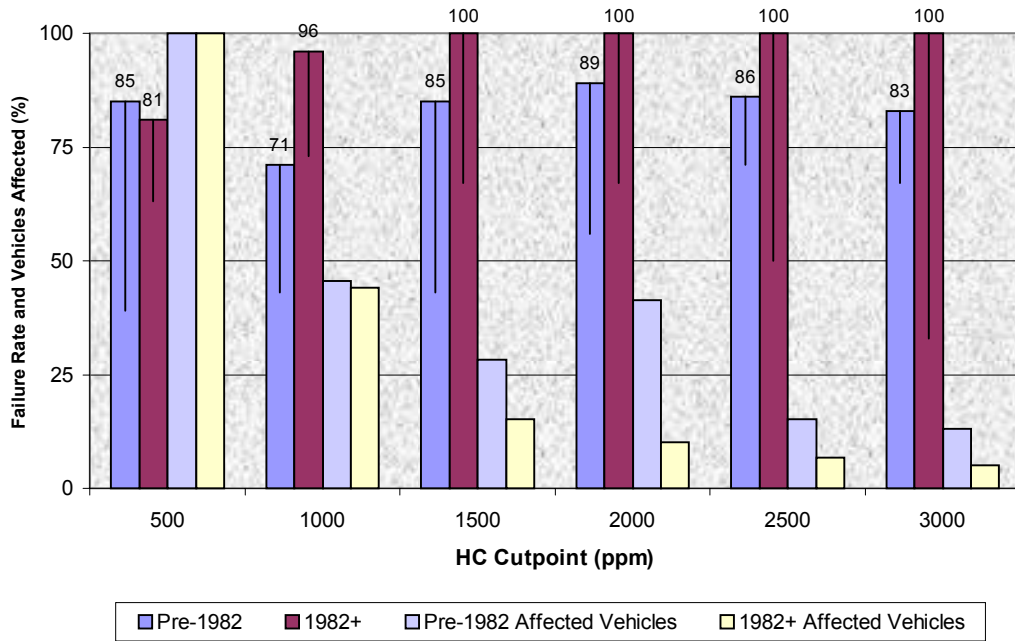
**FIGURE 8**  
**ASM Inspection Failure Rate for RSD Identified HC HEVs**  
**By Model Year Group for Unit 3005**

Note: Lines within bars indicate the portion of the ASM inspection failure rate due to other than HC failure.

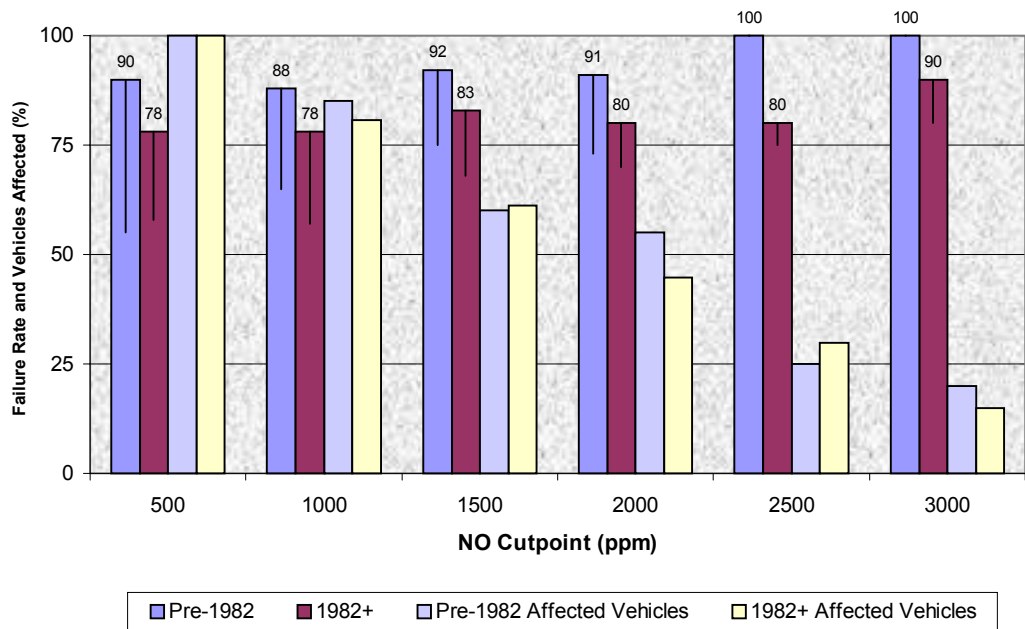
**FIGURE 9**  
**ASM Inspection Failure Rate for RSD Identified NO HEVs**  
**By Model Year Group for Unit 3005**

Note: Lines within bars indicate the portion of the ASM inspection failure rate due to other than NO failure.
